## Field and Laboratory Investigation of the Effect of Water Saturation Variation on the Progressive Instability of Soil Slopes Along the Al-Naqaza Mountain Road, Libya

Abd Albasit Shalfouh<sup>1\*</sup>

, Rabeea Ali Eshaim<sup>2</sup>

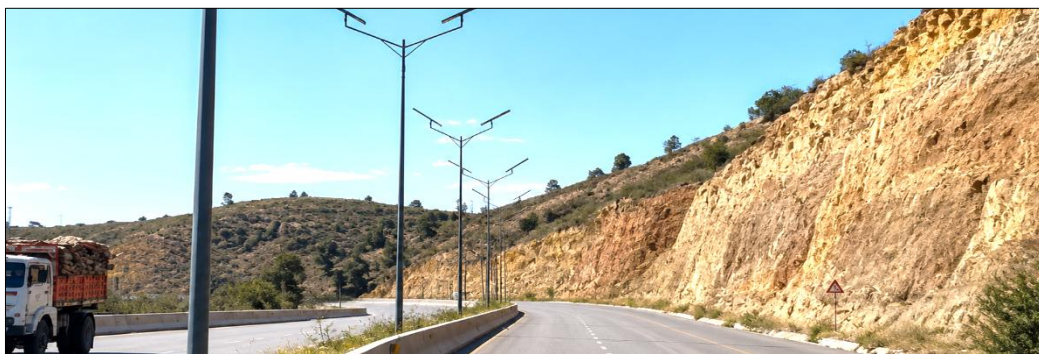
The cut slopes along the Al-Naqaza mountain road (Figure 1) exhibit several indicators of progressive instability. Field observations revealed partial loss of surface soil cover, exposure of tree roots, the presence of cracks and near-vertical joints within the soil mass, and localized surface detachment and disintegration. Horizontal and vertical root extensions protruding through the slope body further reflected ongoing deformation processes. Accordingly, this study aimed to investigate the instability indicators of cut earthen slopes of the cut earthen slopes along the Al-Naqaza mountain road by evaluating the influence of saturation variation on soil shear strength parameters and correlating laboratory findings with field observations.

**Figure 1. Cut slopes along the Al-Naqaza mountain road, Al-Khums.**

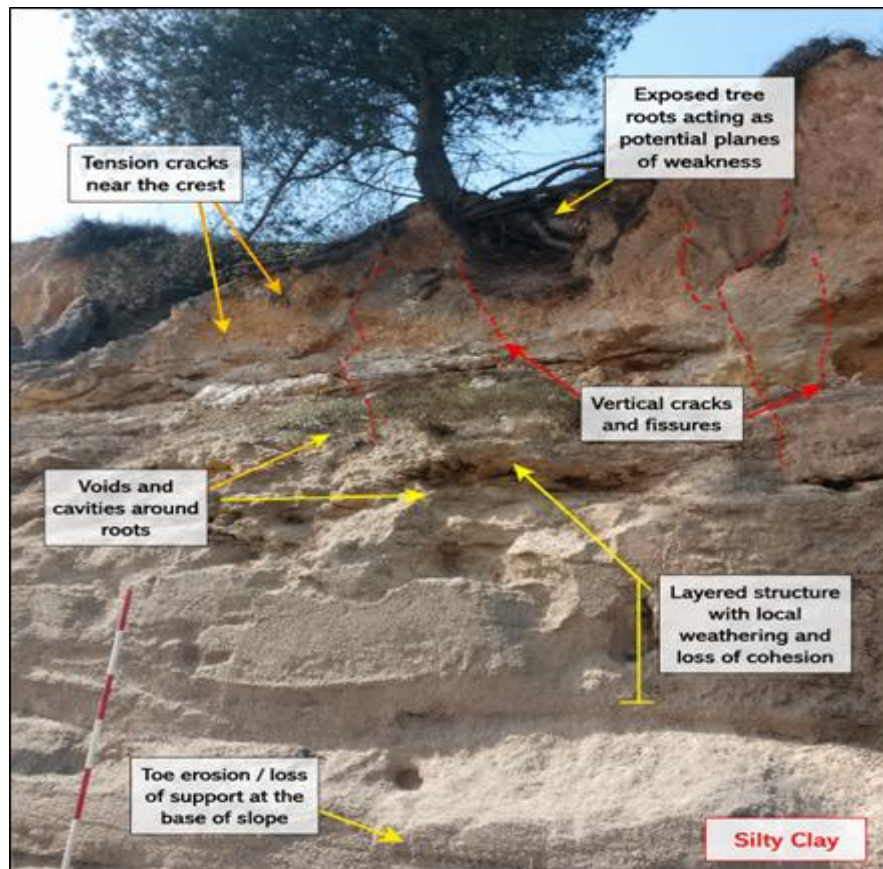
Field observations conducted along the cut slopes of the Al-Naqaza mountain road revealed progressive signs of instability within the soil mass. The investigated slopes had undergone extensive cutting operations, resulting in the removal of a significant portion of the natural toe support and the exposure of the upper soil layers (Figure 6). As a result, tree roots became visibly exposed along several sections of the slope face.

**Figure 6. Field indicators of slope instability in soil.**

Figure 6 shows exposed root systems extending through the soil mass, together with localized voids and gaps formed by the partial detachment of the surrounding soil. In addition, cracks and near-vertical joints were observed in the upper parts of the slope, indicating the progressive development of internal weak zones associated with repeated wetting–drying cycles.

These field conditions suggest that root exposure and soil detachment may contribute to localized weakening within the slope body. The voids surrounding exposed roots can act as preferential pathways for water infiltration, facilitating moisture penetration into deeper soil layers. This process may increase pore water pressure, reduce effective stress, and consequently decrease the shear strength of the soil.

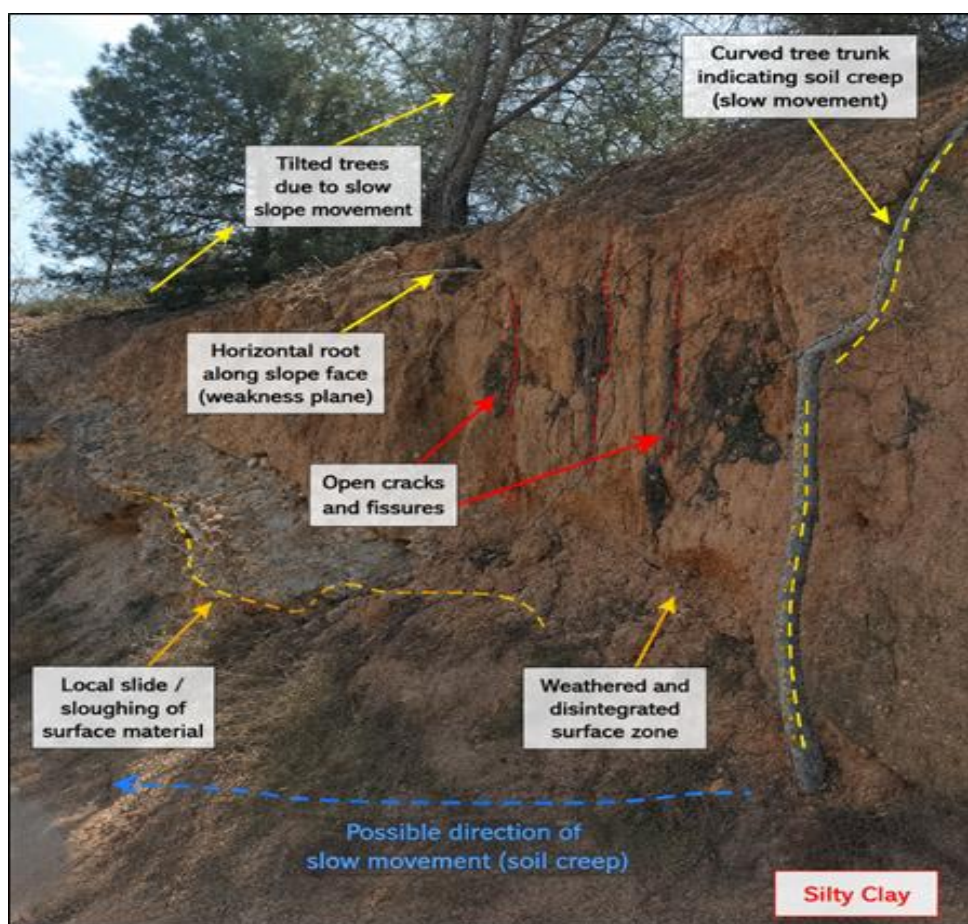
(Figure 7) illustrates progressive surface deterioration along the slope, including exposed root extensions, localized soil disintegration, and shallow surface collapses. Extensive cracking and granular breakdown of the soil can also be observed, indicating progressive weakening of the slope material under the influence of environmental weathering and moisture fluctuations. In several sections, horizontally extending roots appear to coincide with the development of continuous weak zones near the slope surface. These zones may facilitate the formation of shallow slip surfaces under conditions of increased water infiltration and repeated wetting–drying cycles.

**Figure 7. Field evidence of soil creep and progressive slope movement**

Field observations (Figure 7) revealed a noticeable curvature in the trunk of a tree located near the crest of the slope. This deformation is commonly recognized as a geomorphological indicator of soil creep, where slow and continuous downslope soil movement gradually displaces the tree base while the trunk continues to grow vertically. As a result, trunk curvature develops over time. The observed deformation suggests the presence of long-term shallow slope movement, particularly within silty clay soils that are highly sensitive to moisture variation and repeated wetting–drying cycles. These conditions may indicate an early stage of progressive instability preceding localized surface failures.
