Simulation of a Marl Rock Slope Failure Parallel to the Nalut Mountain Road, Libya

In March 2021, a sudden rockfall occurred on the Nalut mountain road, resulting in the closure of this critical transportation route. Notably, the failure took place in the absence of rainfall or other conventional external triggers. This study aims to simulate the failure mechanism and assess the key structural factors contributing to slope instability by integrating field investigations with numerical modeling using RocPlane software. The analysis revealed that the affected slope comprises weak marl rocks and that the dominant factor in the failure was the presence of discontinuity sets, particularly Set 2 and Set 3, inclined at 45°, which intersected with the slope direction and formed a kinematically unstable wedge. This wedge was further facilitated by horizontal joints (Set 4 at 0°), creating conditions for complete structural failure. All discontinuity sets recorded a safety factor of zero, reflecting total instability. The driving force in Sets 2 and 3 was approximately 30.34 t/m, with wedge weights ranging from 42.90 to 48.43 t/m. These findings confirm that internal rock structure, rather

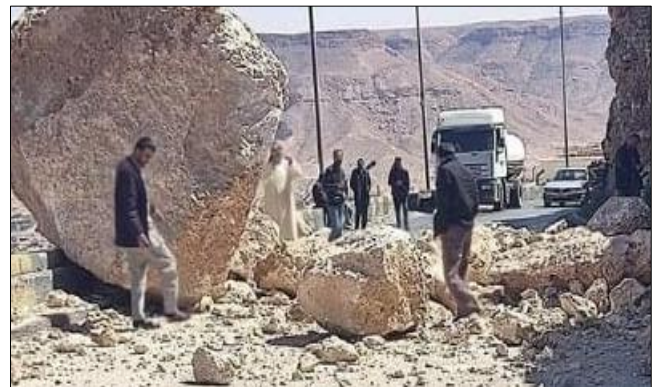
Figure 2: Rockfall on Nalut Road

Considering these challenges, slope stability studies have become essential, with tools like RocPlane offering effective analysis of rock mass stability, especially in wedge failure scenarios [6]. Mountain roads in Libya lack consistent monitoring by government agencies and specialists in civil engineering, road engineering, and geotechnical engineering, particularly after contractors have completed construction work. This oversight creates a critical gap that often leads to hazardous incidents due to the absence of supervision on cut slopes or those supporting the road infrastructure. The severity of such incidents is usually only recognized after material damage has already occurred [7]. The Nalut mountain road is one of the most vital routes in the western mountains, connecting the interior cities of the region with the border area of Wazen city. It serves as a major corridor for various types of motor vehicles and plays a key role in transporting water, goods, and cargo to Nalut city. In March 2021, a sudden rockfall occurred on a slope Parallel to the Road route, resulting in the road's closure (Figure 1). What makes this event particularly noteworthy is that it occurred in the absence of any rainfall, and the failure of rock masses was of varying sizes; see (Figure 2).

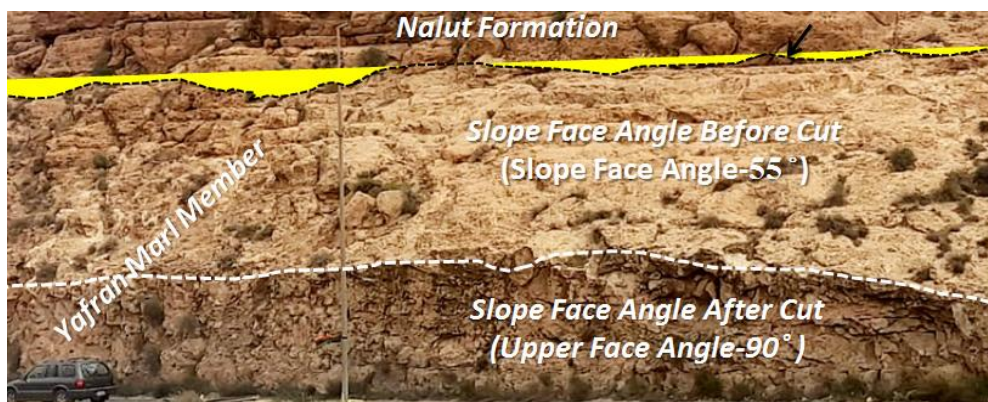
Figure 7. Cross-Section of Nalut Formation and Yafran Marl Member

The area under study covers approximately 180 m². Field observations of weak zones affecting the adjacent, parallel, and lower slopes revealed that the prevailing rocks in the area belong to the Nalut Formation and the Yafran Member, as illustrated in Figure 7. The failure, however, occurred specifically within the marl rocks of the Yafran Marl Member. The geological cross-section shown in Figure 7 depicts a rock profile adjacent to the failure site, consisting of two main stratigraphic units: the Nalut Formation in the upper part and the Yafran Marl Member in the lower part. The affected slope exhibits a significant engineering modification; the slope angle changed from 55° before cutting to 90° after cutting.

The Yafran Marl Member is composed of marl, a fragile sedimentary rock consisting of a mixture of clay and carbonate materials. These rocks are characterized by high structural weakness, significant susceptibility to cracking, and a strong tendency to absorb water. As a result, they are highly prone to disintegration and failure, particularly when subjected to excavation activities or exposed to varying climatic conditions. From a geotechnical perspective, adjusting the dip angle to 90° in marl rocks is unsafe, as it reduces the stability of rock masses and increases the likelihood of failure. This is due to several interrelated factors, most

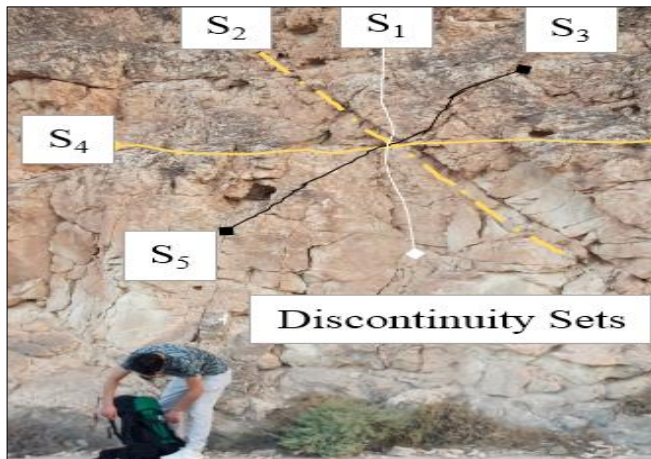
Figure 8. Discontinuity Sets in the Marl

The field study identified five main discontinuity sets within the marl rocks (Figure 8), representing failure plane orientations, with dip angles ranging between 0° and 90° . Notably, two joint sets with an inclination of approximately 45° (S2 and S3) are considered critical, as their orientation aligns with the slope direction; this discontinuity significantly contributed to the occurrence of the mass failure. In addition, horizontal joints (0°) act as potential basal slip surfaces, particularly under conditions of low internal cohesion and reduced friction angles. Vertical joints (90°), especially set S5, which nearly coincides with the slope face (Figure 9), contribute to the fragmentation of rock masses and enhance for failure.

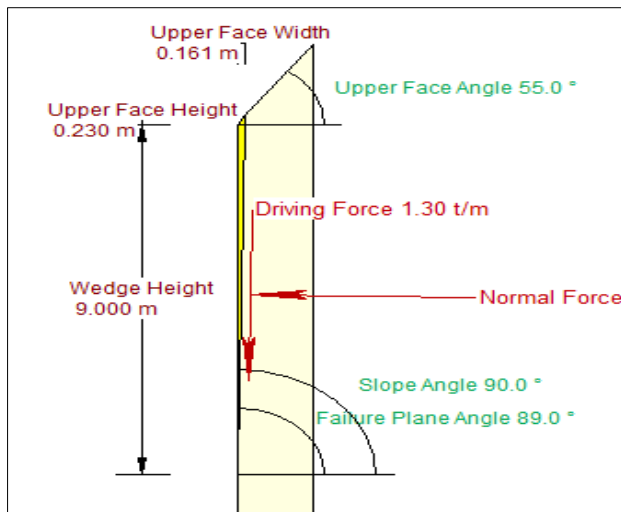
Figure 10. Simulation of 90° Failure Plane

When examining Set1, which represents vertical joints (failure plane angle 90°), the analysis shows a small driving force (1.30 t/m) (Figure 10) with no resistance and a similar wedge weight. Although vertical joints typically do not serve as primary sliding surfaces, their presence can contribute to the detachment of small rock blocks; the low vertical force (0.022 t/m) reflects the limited role of friction along this direction.

Set 5 is similar to Set 1 and represents a vertical joint system. It is characterized by low wedge weight and a limited driving force (1.30 t/m), which reduces its direct impact on slope failure. However, the presence of such vertical joints may compromise the structural integrity of the rock mass and increase its susceptibility to disintegration.

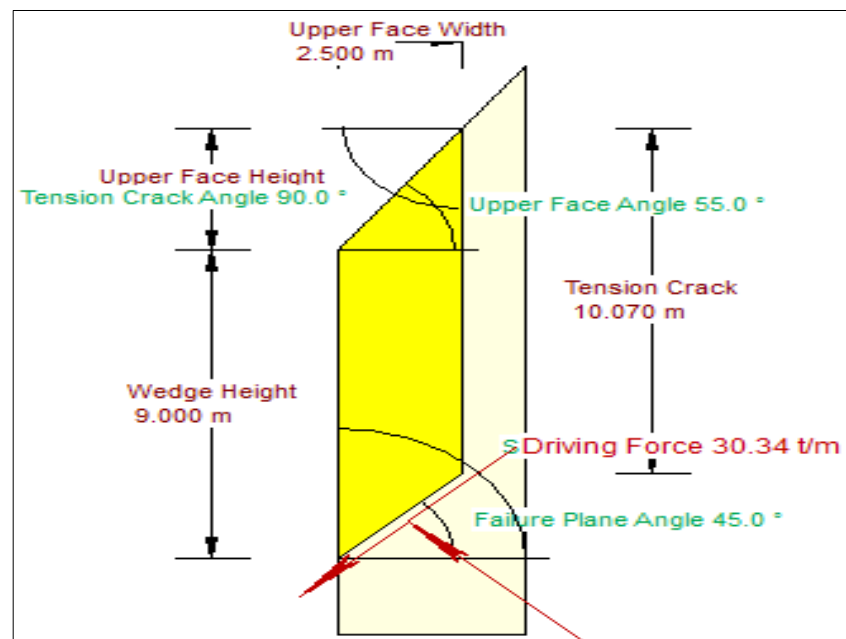
Figure 12. Simulation of 45° Failure Plane

Figure 12 illustrates a simulation of the effect of a 45° failure plane angle on slope instability. The analysis reveals that Set 2 and Set 3 are the primary contributors to the observed failure, as they represent steep, intersecting discontinuity planes that align with the slope direction, enabling rock mass movement. The driving force (30.34 t/m) and wedge weight (42.90 t/m), confirm the instability of these planes.

This destabilizing effect is further exacerbated by Set 4, which forms a weak horizontal base that facilitates block separation even in the absence of groundwater. Notably, failure occurred in the model despite dry conditions, indicating that the high joint continuity, zero cohesion, and low internal friction angle were sufficient to cause failure purely under gravitational stress. Set 2 and Set 3 are considered the most critical, as they consist of 45° inclined joints that directly contributed to the wedge-type failure, with a driving force of 30.34 t/m and a wedge weight of 42.90 t/m. Set 4, despite being horizontal, played a significant role in weakening the base of the rock mass due to its substantial wedge weight (48.43 t/m). Vertical joints (Set 1 and Set 5) had a secondary effect by promoting block disintegration and detachment.
