## Analysis of the Stability of Nalut Formation Outcrops Parallel to Al-Rujban Mountain Road-NW Libya

Reda Almagtuf<sup>1\*</sup>, Aboalgasem Alakhdar<sup>2</sup><sup>1</sup>Department of Geology, Faculty of Science, University of Zawia, Zawia, Libya<sup>2</sup>Department of Geological Engineering, Faculty of Engineering, Nalut University, Jado, LibyaCorresponding Email. [a.alakhdar@nu.edu.ly](mailto:a.alakhdar@nu.edu.ly)

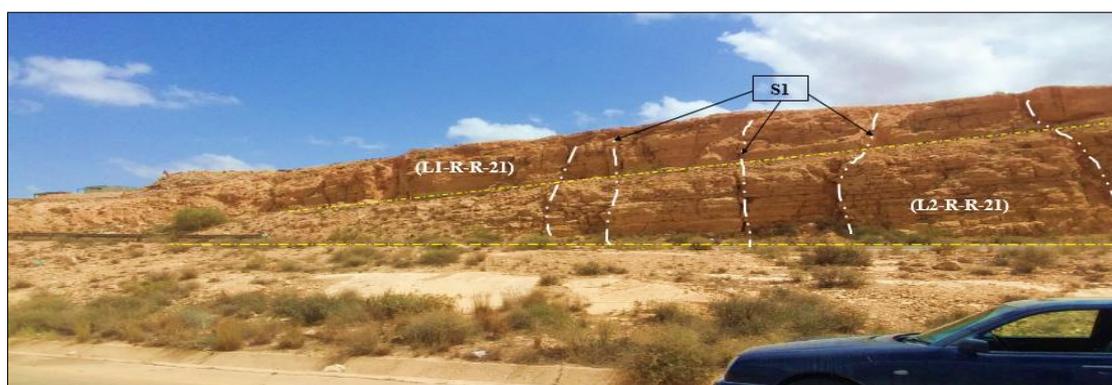
**Figure 2. Location of the studied slopes (L1-R-R-21) & (L2-R-R-21)**

To collect data, a field study was conducted; the field study was the basis for simulating the reality of the slopes. This phase was concerned with field measurements and conducting descriptive and analytical surveys of the reality of the slopes. This phase resulted in the collection of data and information on the research problem and the identification of evidence of the movement of materials, the expected geomorphological risks, as well as making predictions based on field data and evidence. This stage relied on the field study to make measurements related to the geometric properties of rock masses along a survey line of 200 meters distributed at two heights. To evaluate the physical and mechanical properties of the rock outcrops Parallel to the road, the clear outcrops closest to the mountain road were selected. To distinguish the present study from previous studies, a general code was chosen for the study site (L-R-R-21), with the L standing for Location, the R for Road, the R for the term Rujban, and the number 21 for the year of the study 2021 Figure 2.

Upon examining figure 2, it is evident that the joint system S1 passes through both sites. This suggests that the joints formed after the deposition of carbonate rocks. Additionally, their internal extension lies beneath the roads, presenting an invisible hazard. These joints create weak zones that contribute to the collapse of the rock masses supporting the road, leading to subsidence and potential road damage.

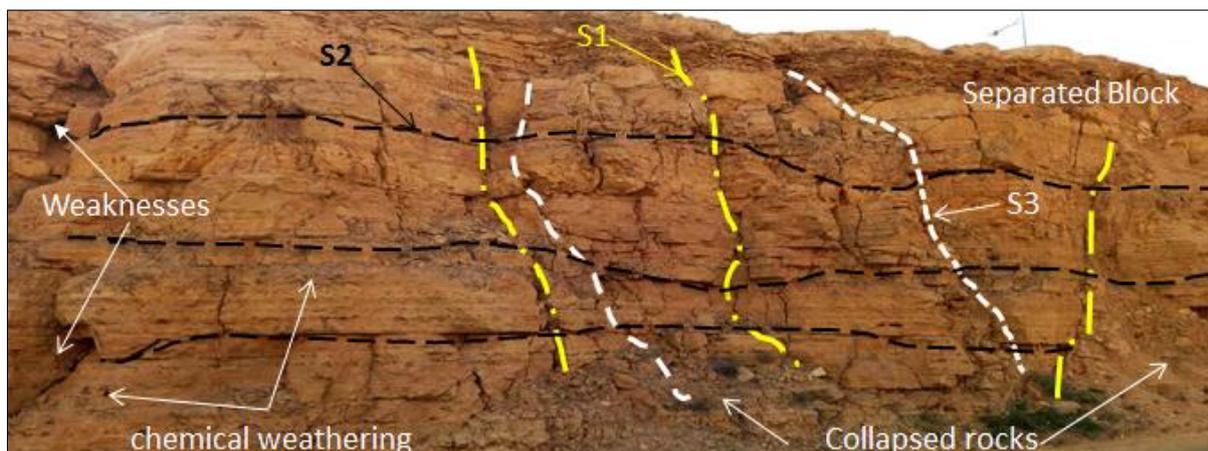
**Figure 3. Outcrop Parallel in the site (L1-R-R-21).**

**Site (L1-R-R-21):** Figure 3 illustrates part of the studied outcrop, where field visits identified disturbing samples prone to avalanche. The rocks belong to dolomite, and the parallel slopes are part of the excavations for the Al-Rujban mountain road, showing regularly cut rocks. The road lacks shoulders or trenches to contain avalanched sediments. Drainage streams are blocked by sediment, hindering water flow and pushing debris onto the road, which can obstruct traffic and cause vehicle skidding. Regarding weathering, several joint systems were observed, with random cracks indicating mechanical weathering, while chemical weathering was minimal, showing only narrow calcite deposits.

Three joint systems (S1, S2, S3) intersect at angles up to 90°, leading to the separation of rock masses. This increases the risk of large rock avalanches reaching the road, which is only two meters away. The joints, averaging 2.5 meters in length, are classified as medium-sized, with an average internal extension of 75 cm. The joints are filled with rock debris, often incoherent, indicating a lack of binding materials that could contribute to slope stability. The field study revealed that the main joints (S1, S3) function as waterways sloping toward the road, contributing to erosion, material removal, and rock debris avalanches, forming conical shapes with a stability angle of 45°.

The slopes alongside the road facilitate the transport of avalanched materials toward the road. Instead of falling directly, rock masses move toward the road due to the new slopes with cutting angles between  $75^\circ$  and  $90^\circ$ , leading to rock falls. In the conical areas, the rock masses exhibit rolling and jumping behavior, as the rocks are hard. The geometric and mathematical analysis in table 8 showed that the joint separation is moderately narrow, with no binding materials, allowing smooth water flow. The joint spacing, with an average of 89.9 cm, is classified as widely spaced, contributing to an RQD of 44%, indicating a stable outcrop

Site area	300 m <sup>2</sup>
Roughness Type	Medium
Continuity	75 cm
Type of Movement	Rock Fill
Infilling Materials	Carbonate and Mud
Slope Angle	$75^\circ$ - $90^\circ$ - Poor
RQD	44 %
Joint Spacing (JS)	89.9cm —Widely Spaced
Separation	60 - 200 mm—Moderately narrow
