## Field and Laboratory Investigation of the Effect of Water Saturation Variation on the Progressive Instability of Soil Slopes Along the Al-Naqaza Mountain Road, Libya

Abd Albasit Shalfouh<sup>1\*</sup>

, Rabeea Ali Eshaim<sup>2</sup>

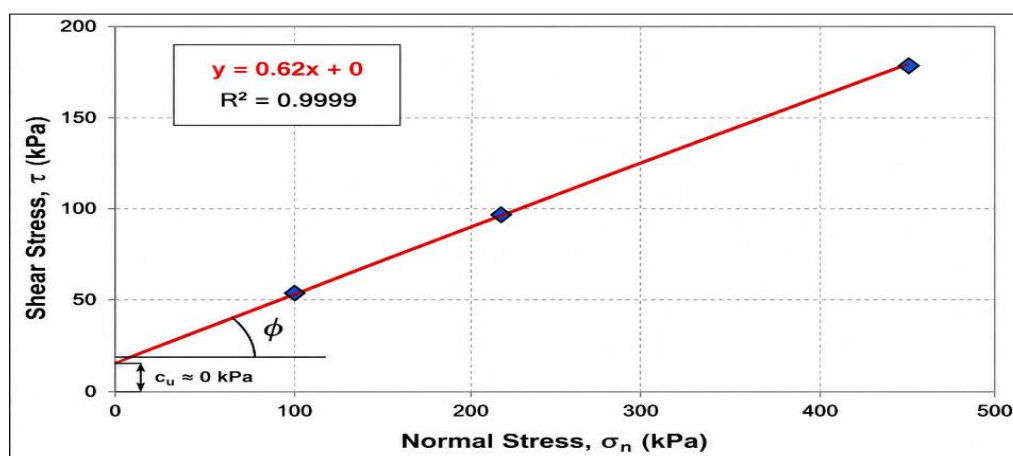
**Figure 5. Relationship between normal and shear stress for the dry soil sample.**

The experimental data were processed and analyzed to establish the relationship between normal stress and shear stress at failure in accordance with the Mohr–Coulomb failure criterion. Linear regression analysis was performed to define the failure envelope for each moisture condition. The cohesion ( $c$ ) and internal friction angle ( $\phi$ ) were subsequently determined from the intercept and slope of the corresponding regression line, respectively (Figure 5).

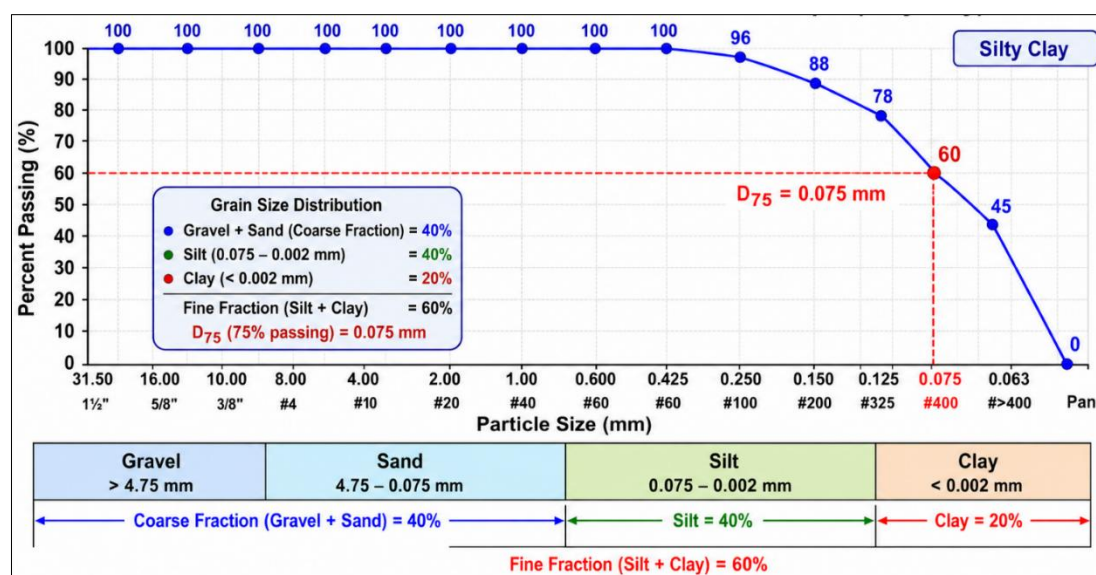
**Figure 8. Grain size distribution curve of the silty clay soil sample**

In addition, the grain size distribution curve presented in Figure 8 indicates a predominance of fine particles within the soil matrix, with limited representation of coarse fractions. The dominance of fine-grained material contributes to reduced drainage capability and increased moisture retention, making the soil more vulnerable to erosion, softening, and shallow surface instability under saturated conditions.

The sieve analysis results are consistent with the field observations, which revealed localized surface disintegration, exposed roots, and near-vertical cracking within the slope body. Silty clay soils are particularly susceptible to shrinkage and crack development during drying periods, followed by a substantial reduction in strength upon re-wetting, as reported in previous studies [14]. In addition, the presence of exposed roots within the slope may locally influence the mechanical behavior of the soil after cutting operations. Partial root exposure, root decomposition, and detachment of the surrounding soil can contribute to the formation of localized voids and preferential pathways for water infiltration into the slope mass.

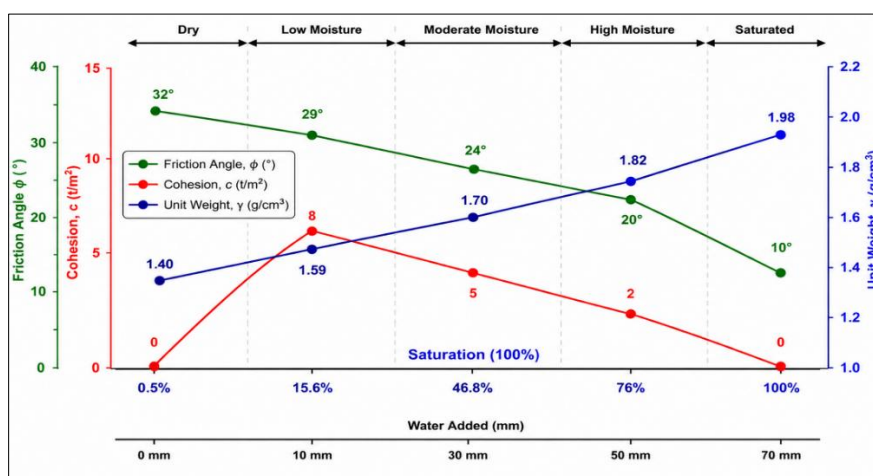
**Figure 9. Relationship Between Water Saturation and Shear Strength Parameters**

It can also be observed that the bulk density of the soil increased progressively with increasing saturation (Figure 9), rising from approximately 1.4  $g/cm^3$  to 1.98  $g/cm^3$ . This increase reflects the additional water retained within the soil mass and results in higher self-weight loading acting on the slope. Consequently, the driving forces acting downslope become greater, particularly under conditions where the slope geometry remains unchanged. The combined effect of increasing soil unit weight and decreasing shear strength parameters contributes to a progressive reduction in slope stability and increases the likelihood of shallow slope failure under high moisture conditions.

These findings are consistent with the field observations obtained from the slopes in the Al-Naqaza area, where visible cracking, localized soil disintegration, exposed roots, and indications of slow soil creep were identified. The presence of cracks and exposed root zones facilitates water infiltration into the soil mass, progressively increasing the saturation and contributing to the deterioration of the soil's mechanical properties, as demonstrated in (Table 2). In particular, the significant reduction in the internal friction angle

under high moisture conditions provides a reasonable explanation for the shallow surface collapses and progressive disintegration observed along the slope face.
