Simulation of a Marl Rock Slope Failure Parallel to the Nalut Mountain Road, Libya

In March 2021, a sudden rockfall occurred on the Nalut mountain road, resulting in the closure of this critical transportation route. Notably, the failure took place in the absence of rainfall or other conventional external triggers. This study aims to simulate the failure mechanism and assess the key structural factors contributing to slope instability by integrating field investigations with numerical modeling using RocPlane software. The analysis revealed that the affected slope comprises weak marl rocks and that the dominant factor in the failure was the presence of discontinuity sets, particularly Set 2 and Set 3, inclined at 45°, which intersected with the slope direction and formed a kinematically unstable wedge. This wedge was further facilitated by horizontal joints (Set 4 at 0°), creating conditions for complete structural failure. All discontinuity sets recorded a safety factor of zero, reflecting total instability. The driving force in Sets 2 and 3 was approximately 30.34 t/m, with wedge weights ranging from 42.90 to 48.43 t/m. These findings confirm that internal rock structure, rather

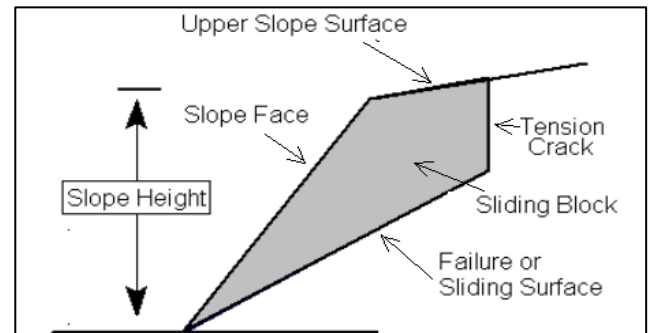
Figure 6. Structure of slope

The area under study covers approximately 180 m². Field observations of weak zones affecting the adjacent, parallel, and lower slopes revealed that the prevailing rocks in the area belong to the Nalut Formation and the Yafran Member, as illustrated in Figure 7. The failure, however, occurred specifically within the marl rocks of the Yafran Marl Member. The geological cross-section shown in Figure 7 depicts a rock profile adjacent to the failure site, consisting of two main stratigraphic units: the Nalut Formation in the upper part and the Yafran Marl Member in the lower part. The affected slope exhibits a significant engineering modification; the slope angle changed from 55° before cutting to 90° after cutting.
